Lessons learned from the bridge collapse in Palau

The collapse of a record-breaking 240 m span prestressed-concrete bridge in the Pacific Island nation of Palau occurred without warning in 1996. The parties involved were subject to a confidentiality agreement, so no definitive statement has been made as to the cause of the collapse. This paper reports on a study carried out using information in the public domain. It concludes that a repair carried out six weeks before the collapse was not to blame, but did expose weaknesses in the original design. It is recommended that the construction industry should not shelter behind confidentiality clauses but, like the aircraft industry, publish its mistakes so lessons can be learned.

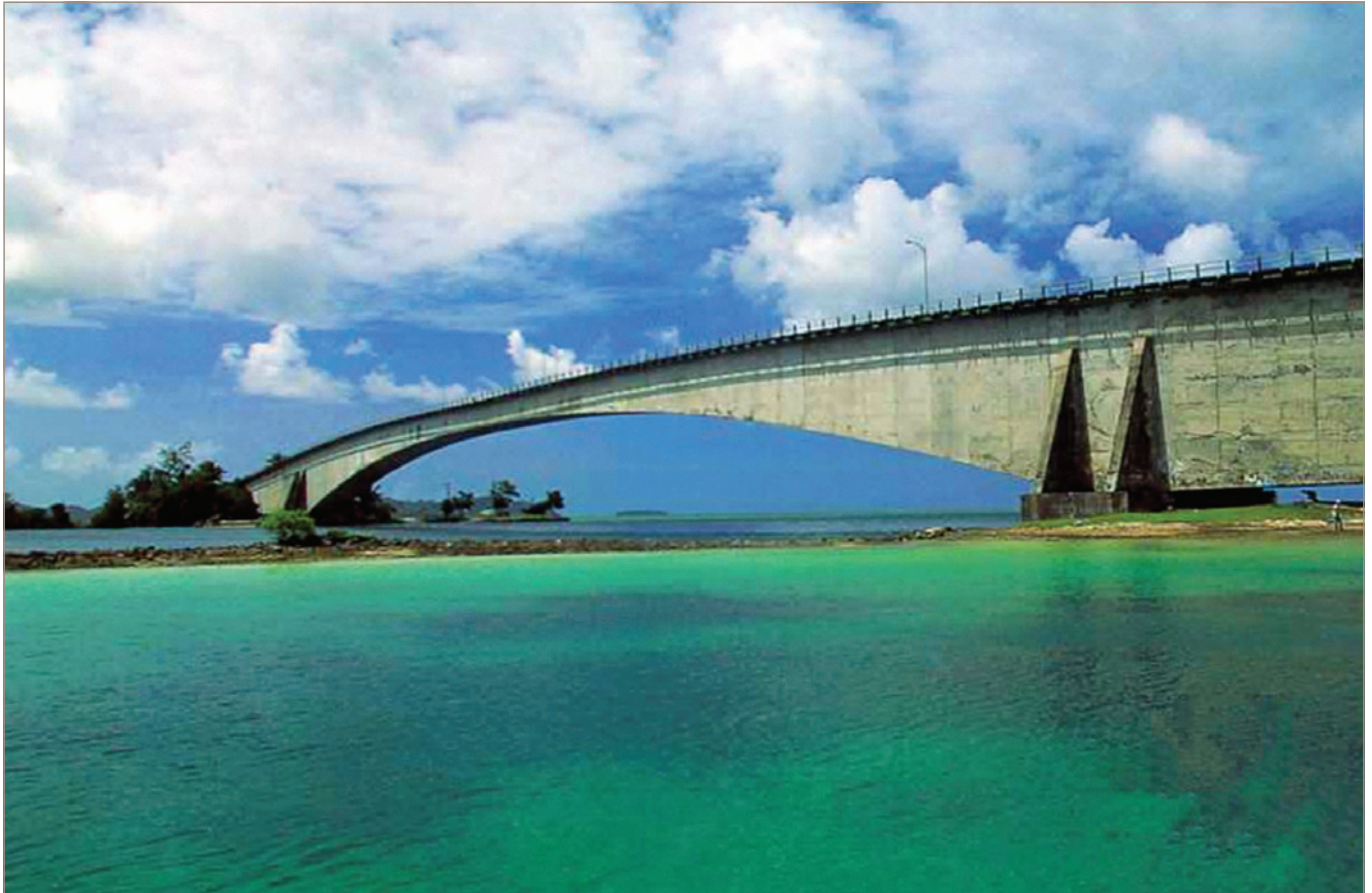
Fig. 1. The 240 m span Koror-Babelthuap Bridge in Palau held the world record for prestressed concrete beam bridges when completed in 1977. However, by the 1990s, creep sag at mid-span had reached a clearly visible 1.2 m

After completion, the bridge remained unchanged for 18 years. Over this period, the cantilevers deflected due to creep, shrinkage and prestress loss. By 1990 the sag of the centreline had reached 1.2 m, affecting the appearance of the bridge and causing discomfort to road users and damage to the wearing surface.

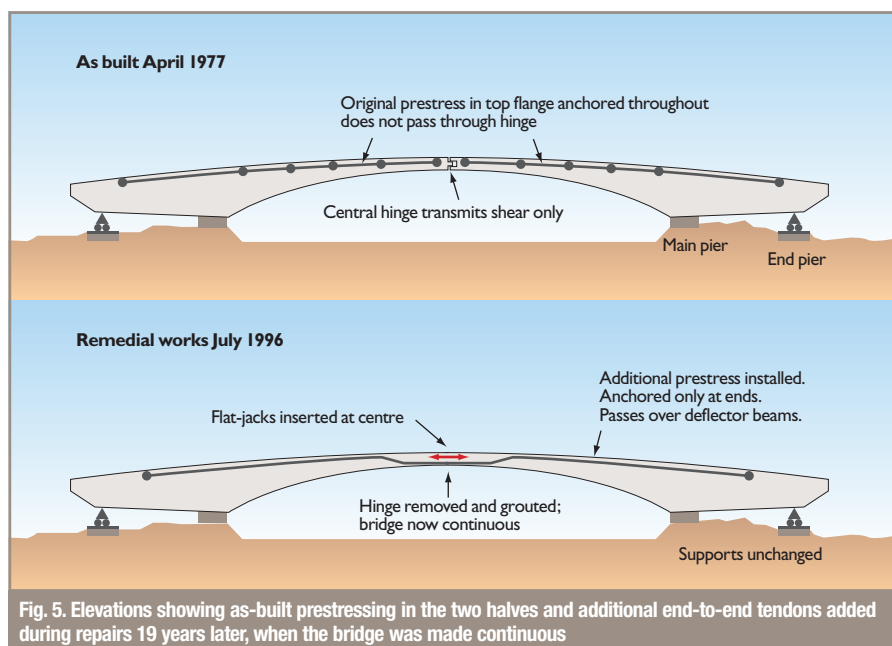
Fig. 5. Elevations showing as-built prestressing in the two halves and additional end-to-end tendons added during repairs 19 years later, when the bridge was made continuous

- Removal of the central hinge to make the structure continuous.
- Installation of eight additional, external, post-tensioned prestressing cables inside the box section, running beneath the top slab near the main pier and, via two deviator beams on each side, moving to the bottom of the box near the centre. These additional tendons were continuous through the bridge, being anchored between the piers on each side. 36 MN of force was applied to these cables, creating a hogging central moment intended to

- Insertion of flat-jacks between the top slabs (in place of the central hinge), which were used to apply an additional 31 MN of longitudinal compressive force. These were grouted in place, making the span continuous. The combined effect of the external cables and flat-jacks is referred to here as the 'additional prestress'. The decision to make the bridge continuous was a late amendment to the design, and apparently taken on economic grounds since it allowed the new cables to pass from one half-span to the other, thus halving the number of anchorages required.
- Replacement of the bridge surface throughout. Because the prestress would not eliminate all the sag, a lightweight void former was to be inserted over the central area under the new surface to provide a smooth running surface.

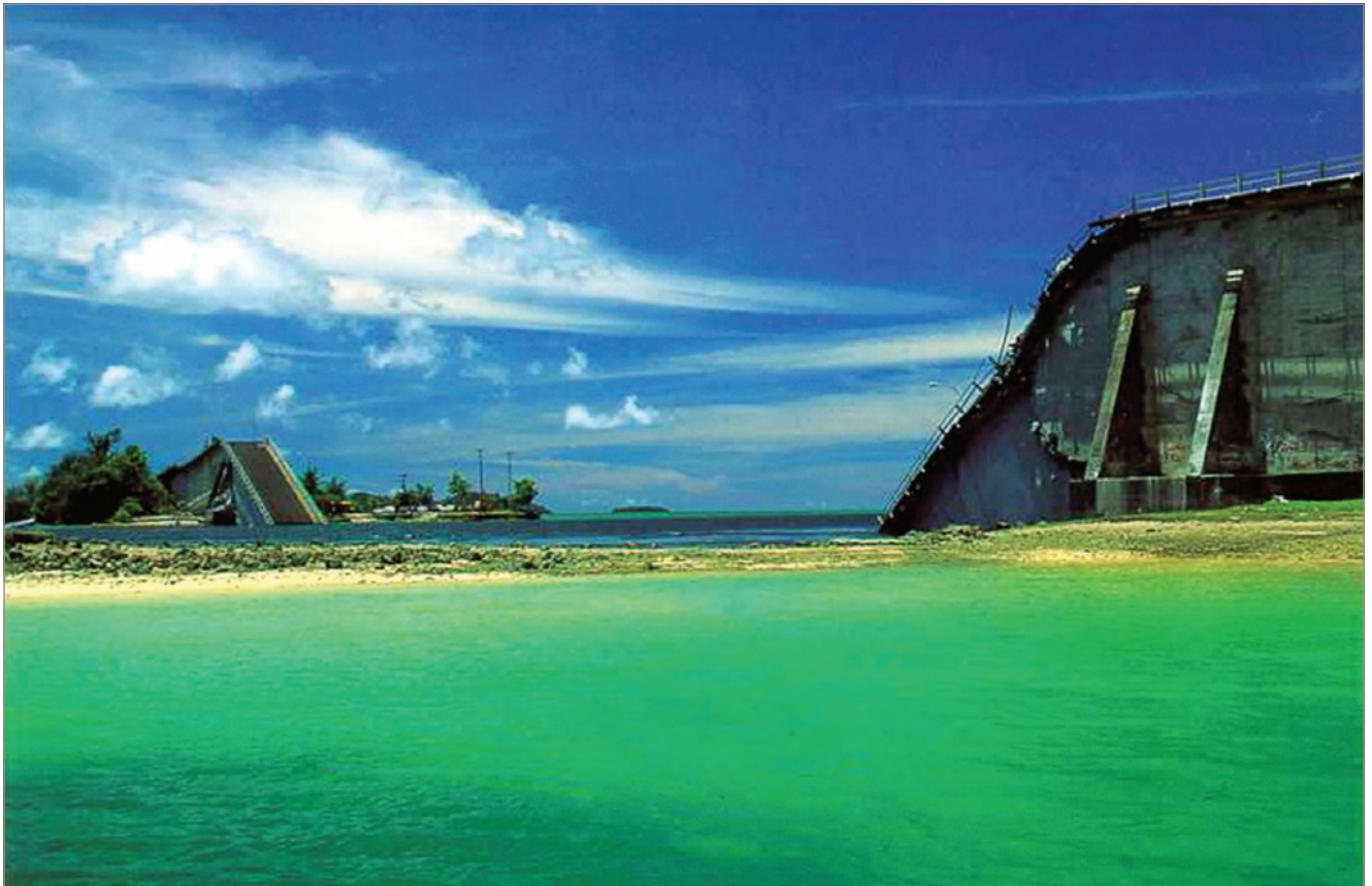
The bridge collapsed six weeks later (Fig. 6). A report prepared for the US Army¹¹ describes in detail the most likely mechanism of collapse, inferred from eye-witness accounts and from visible damage to the bridge both above and below water level. A summary of the damaged regions is shown in Fig. 7. The 'pockmarks' indicated in the figure were not mentioned in the report, but were discovered during later failure analysis.

Fig. 6. Six weeks after repairs were completed, the bridge collapsed into the 30 m deep channel at 5:45 pm on 26 September 1996, killing two people and triggering a national emergency

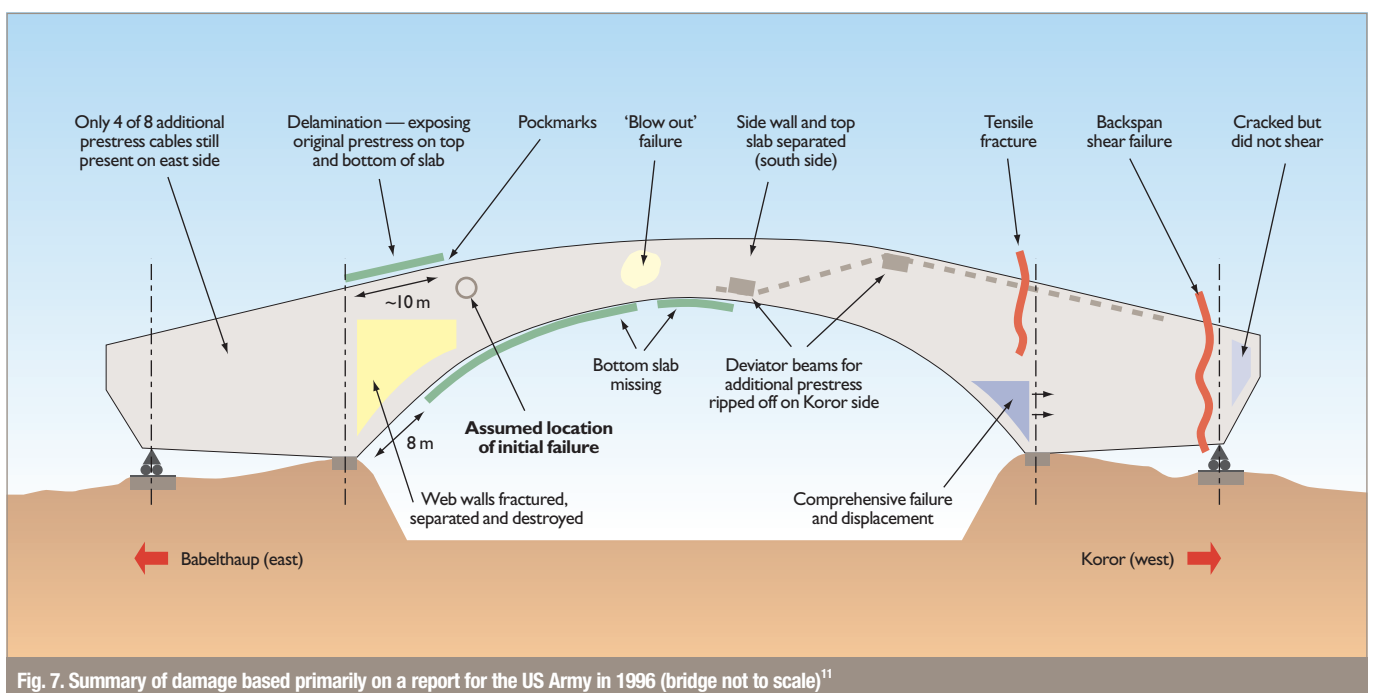
- Delamination of the top flange occurred near the main pier on the Babelthuap side. This 'rendered it incapable of providing resistance against the original post-tensioning forces...causing the rest of the girder to behave as a reinforced concrete girder spanning between the [centre] and the [Babelthuap] main pier'.
- Large hogging moments resulted over the main pier, inducing far greater tensile stresses in the top slab and upper region of the webs than could be sustained. The webs therefore failed at the top, resulting in near total loss of their shear capacity. As a result, the Babelthuap side of the span failed in shear, next to the main pier.
- The weight of both halves of the main span therefore acted on the Koror side. Unable to sustain this increased load, the remainder of the bridge rotated around the Koror-side main pier, shearing the

Fig. 7. Summary of damage based primarily on a report for the US Army in 1996 (bridge not to scale)¹¹

- The resulting compressive stresses just east of the Koror main pier caused the base of the box girder to crush and displace into the pier itself. The top slab then failed in tension, the backspan fell to the ground and the central span dropped into the channel.

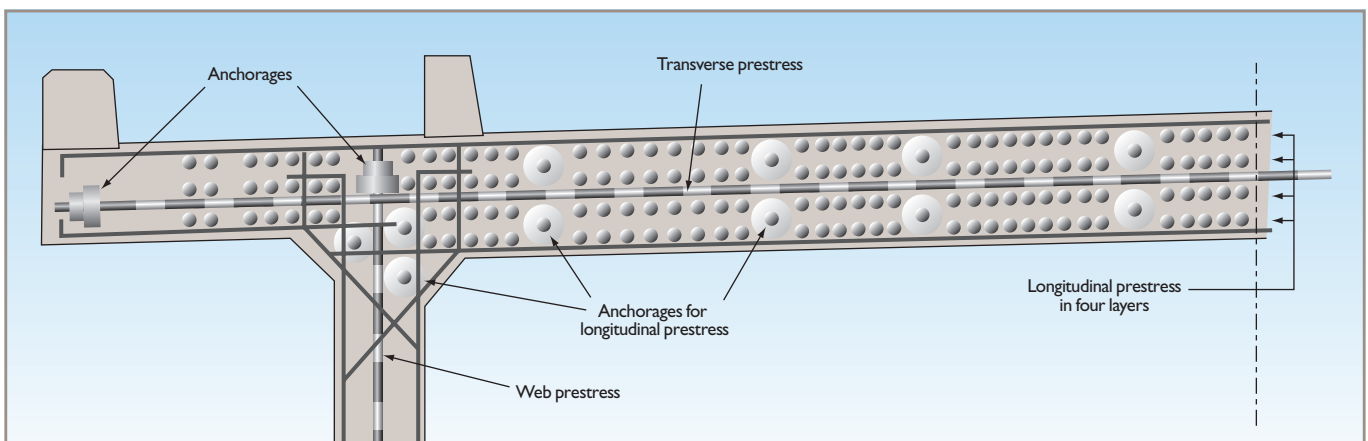
Fig. 8. Cross-section of as-built top flange near where the bridge initially failed—un-reinforced concrete around some of the upper prestress anchorages may have been damaged during replacement of the road surface six weeks earlier

The amount of material removed is unlikely to have caused global effects, but it is possible it caused some local effects. Fig. 8 shows details of the top flange⁹ and Fig. 9 shows a photograph of this region from inside the box, taken after the collapse.⁶ What can be seen from these figures is heavy congestion of prestressing ducts, anchors and couplers. Reports from observation after the collapse⁹ indicate that the prestress spacing reduced to as little as 25 mm in the vicinity of the piers. In addition, the absence of through-thickness or bursting reinforcement is notable, even in the vicinity of the anchorages, and there seems to be relatively little connectivity between the shear steel in the web and the steel in the top flange.

It was thus postulated that local damage to the concrete led to weakening of the unreinforced concrete next to an anchorage. The collapse took place six weeks after resurfacing was complete, which indicates that the process must have been relatively slow. The probability is that the damage caused by breaking out the old surfacing allowed local stresses to rise to such a level that fairly rapid creep of the concrete occurred next to an anchorage. This in turn led to damage to the concrete between the prestressing layers, thus forming a plane of weakness. These weak planes led to the reported delamination that took place in the 30 minutes preceding the failure. There would thus have been a sequence of events accounting for reports that the failure took place slowly.

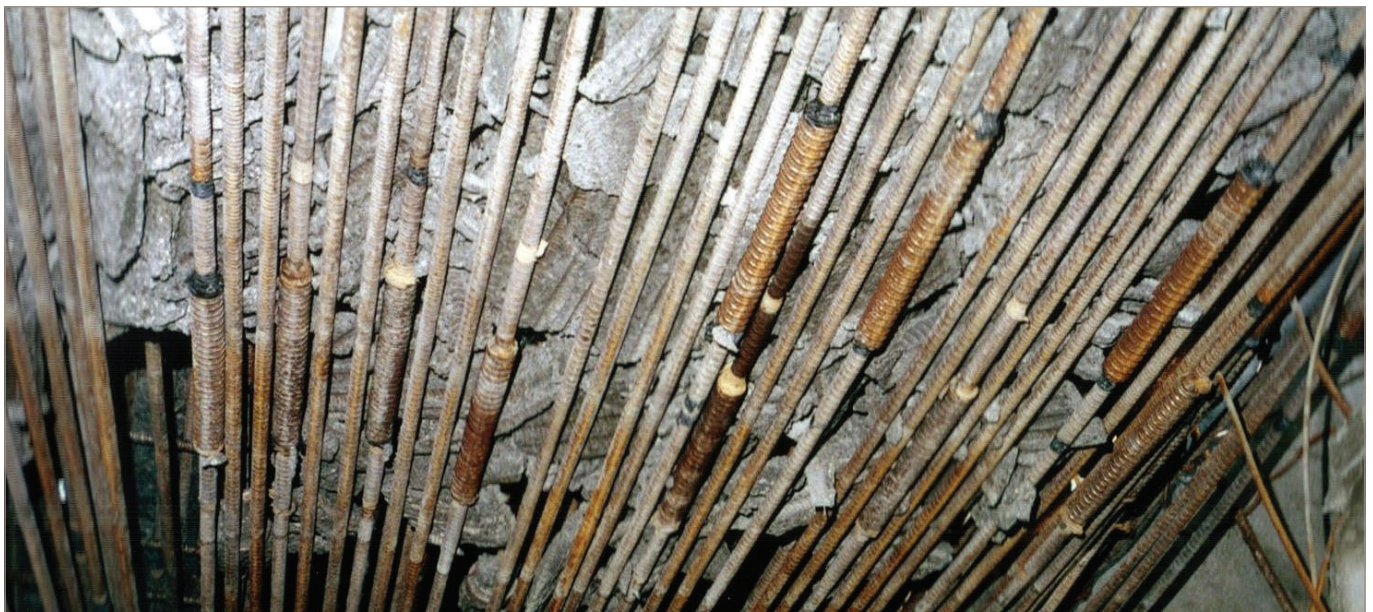
Fig. 9. Underside of the top flange in the initial failure area showing delamination of the lowest layer of closely spaced prestress ducts and lack of vertical links⁶

noteworthy and must have caused problems during construction. Ensuring compaction of the concrete between and beneath the prestress bars must have been difficult. It would be interesting to see the justification for the lack of secondary steel in the top slab, especially in and around the anchorage locations where local stress concentrations would be expected.
