Lessons learned from the bridge collapse in Palau

The collapse of a record-breaking 240 m span prestressed-concrete bridge in the Pacific Island nation of Palau occurred without warning in 1996. The parties involved were subject to a confidentiality agreement, so no definitive statement has been made as to the cause of the collapse. This paper reports on a study carried out using information in the public domain. It concludes that a repair carried out six weeks before the collapse was not to blame, but did expose weaknesses in the original design. It is recommended that the construction industry should not shelter behind confidentiality clauses but, like the aircraft industry, publish its mistakes so lessons can be learned.

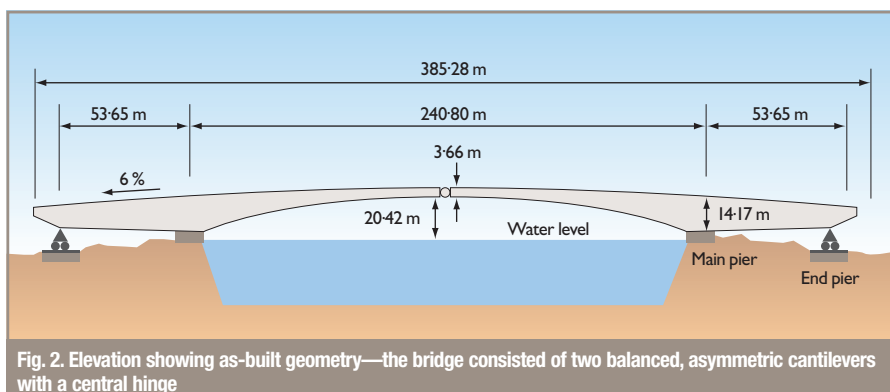
Fig. 2. Elevation showing as-built geometry—the bridge consisted of two balanced, asymmetric cantilevers with a central hinge

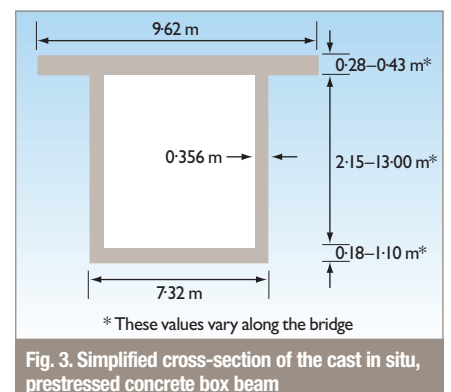
Fig. 3. Simplified cross-section of the cast in situ, prestressed concrete box beam

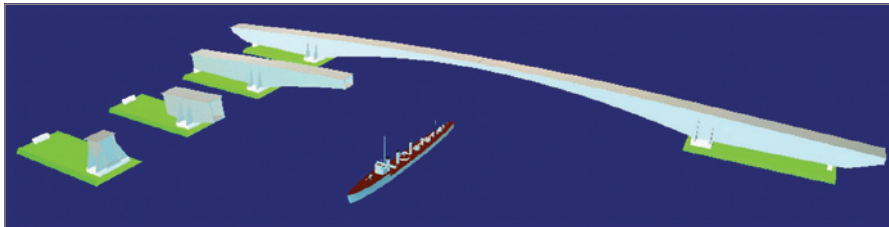
Fig. 4. Graphic showing construction sequence—the back-spans were filled with ballast prior to completion of the cantilevers

from the main pier, until the back span reached the end pier (Fig. 4). This span was then filled with ballast to provide moment reaction for completion of the cantilevers. The end supports were provided with a tie-down facility but should at all times have been in tension.
